*Subject: Accord Structural Safety Assessment for Space Sweater Ltd (Jogitala) (23383).*

*Factory Name: Space Sweater Ltd (Jogitala) (Accord Id: 23383)*

## Structural Safety Inspection Report

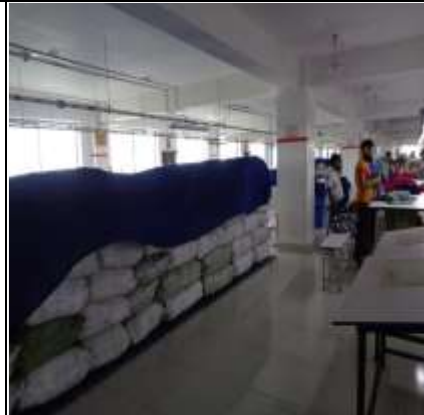
| Item No | Accord Observation | Accord Recommendation | Accord Timeline | Final Action Plan | Final Timeline(dd-mm-yyyy) | Comments after Physical Inspection | Progress Status | Pictorial Evidence |
|---|---|---|---|---|---|---|---|---|
| 1 | Foundation to be stressed above normal design limit | Maintain 3kPa live load on typical floor and 2kPa on toilet zone. | within 6 weeks | We already engage engineering consultant to do the above requirements of Detailed Engineering Assessment (DEA). Our consultant already done the DEA analysis as per Bangladesh National Building Code (BNBC) standard. After completion we already submit the DEA analysis to Accord on 9th September 2018 | 09-Sep-2018 | <b>On 20/05/2019:</b> Load was found below 3 kPa on all floors and 2 kPa on toilet zone.<br><b>On 15-Mar-2020:</b> Corrected from previous inspection. During inspection load was found within 3 Kpa as per accepted load plan. | Corrected | |

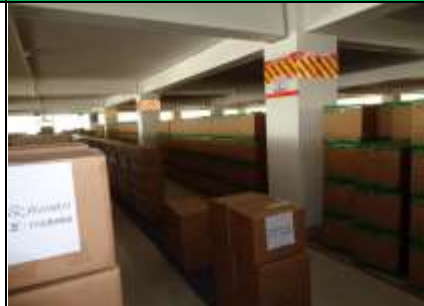
| Item No | Accord Observation | Accord Recommendation | Accord Timeline | Final Action Plan | Final Timeline(dd-mm-yyyy) | Comments after Physical Inspection | Progress Status | Pictorial Evidence |
|---|---|---|---|---|---|---|---|---|
| 3 | Foundation to be stressed above normal design limit | Produce and actively manage a loading plan for all floor plates within the factory, giving consideration to floor, column and foundation capacity. | within 6 weeks | Based on this requirements we nominate a engineering consultant to do the detail engineering assessment (DEA). Our consultant done the DEA. We submitted the revised DEA to Accord on 30th January 2020 | 09-Sep-2018 | <p><b>On 20/05/2019:</b> Load plan has been prepared as part of DEA and submitted to ACCORD on 20/12/2018 which required some revision. Factory was required to submit revised DEA to ACCORD within 20/05/2019. However, load was found below 3kPa on all floors.</p> <p><b>On 15-Mar-2020:</b> Load plan has been produced and accepted as a part of DEA. During inspection load was found within 3 Kpa as per accepted load plan.</p> | Corrected | |

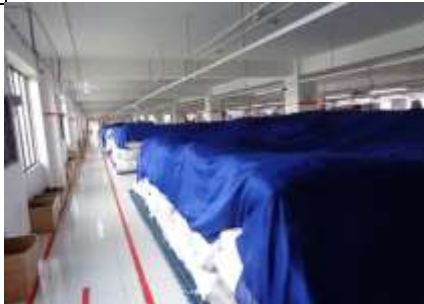
| Item No | Accord Observation | Accord Recommendation | Accord Timeline | Final Action Plan | Final Timeline(dd-mm-yyyy) | Comments after Physical Inspection | Progress Status | Pictorial Evidence |
|---|---|---|---|---|---|---|---|---|
| 5 | Foundation to be stressed above normal design limit | Continue to implement loading plan. | within 6 months | Based on this requirements we nominate a engineering consultant to do the detail engineering assessment (DEA). Our consultant done the DEA. We submitted the revised DEA to Accord on 30th January 2020 | 28-Feb-2019 | <p><b>On 20/05/2019:</b> Load plan has been prepared as part of DEA and submitted to ACCORD on 20/12/2018 which required some revision. Factory was required to submit revised DEA to ACCORD within 20/05/2019. However, load was found below 3kPa on all floors.</p> <p><b>On 15-Mar-2020:</b> Load plan has been produced and accepted as a part of DEA. During inspection load was found within 3 Kpa as per accepted load plan.</p> | Corrected | |

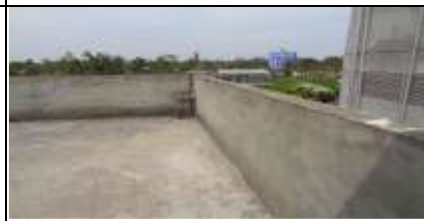
| Item No | Accord Observation | Accord Recommendation | Accord Timeline | Final Action Plan | Final Timeline(dd-mm-yyyy) | Comments after Physical Inspection | Progress Status | Pictorial Evidence |
|---|---|---|---|---|---|---|---|---|
| 12 | Expose rebar and falling hazard risk at roof. | Provide periphery railing/parapet wall to avoid possible falling hazard. | within 6 weeks | we already install railing & construct parapet wall in all required area with ensure the minimum height | 10-Oct-2018 | <b>On 20/05/2019:</b> Factory has provided parapet wall on the roof top to avoid possible falling.<br><b>On 15-Mar-2020:</b> Corrected from previous inspection. Factory has provided parapet wall at roof level to avoid falling hazard. | Corrected | |
