FIRE SAFETY FOLLOW UP INSPECTION

Factory Name	Space Sweater Ltd (Jogitala)		Factory ID	23383
Address	Shi-145/1, Jogitola, Joydebpur,			
Initial Inspection Date	02-Jul-2018		Report Received Date	
Date of 1st Follow-up	14-May-2019	Date of 2nd Follow-up	19-Mar-2020	
Date of 3rd Follow-up	12-Dec-2021	Date of 4th Follow-up	04-Sep-2022	
Date of 5th Follow-up		Date of 6th Follow-up		
Date of 7th Follow-up		Date of 8th Follow-up		
Date of 9th Follow-up		Date of 10th Follow-up		
Date of 11th Follow-up		Date of 12th Follow-up		
Date of 13th Follow-up		Date of 14th Follow-up		
Date of 15th Follow-up		Date of 16th Follow-up		
Date of 17th Follow-up		Date of 18th Follow-up		
Date of 19th Follow-up		Date of 20th Follow-up		
Inspected by	Pantha Pallob Das

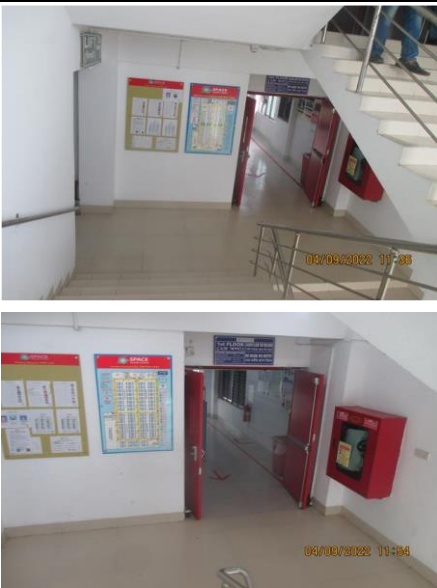
Item No	Inspection Observation	Inspection Recommendation	Timeline given	Comments after Physical Inspection	Supposed to complete(DD/MM/YYYY)	Final Action Plan (Factory)	Status on the date of Inspection	Pictorial Evidence
2	The exit stairs are not separated from [work areas, other spaces] on each floor by fire-rated construction.	Provide minimum 2-hr fire rated doors and seal all unprotected openings to separate the exit stairs from work areas and other building spaces on all floor levels. Ensure that the fire rated doors are self-closing and positive latching and that they are provided with fire exit (panic) hardware where serving production floors. If fire rated doors are required to be held open for functional reasons, provide automatic closing devices tied to the fire alarm system. Once fire doors are installed, every door in a stair enclosure serving more than 5 stories shall be provided with re-entry unless it meets ACCORD standard 6.8.3.1 If fire doors are required to be held open for functional reasons, provide automatic-closing devices tied to the fire alarm system.	Within 3 Months	On 03/10/2018: Extension of timeline is accepted. Extended timeline is valid till 28/11/2018. On 14/05/2019: Factory has installed fire rated doors. But during inspection doors were not latching properly and the clearance under the bottom of a some doors were exceeded the standard. Moreover, during inspections fire door was found open by external means. Factory shall interface the fire doors with fire alarm system if wants to keep them open. On 19/03/2020: Corrected. During inspection fire doors were properly functional. On 31/08/2021 (Special Inspection): Not verified. On 12/12/2021: Corrected. On 04/09/2022: Corrected.	28-Nov-2018	As per your accord guidelines, We have separated staircase from work areas and others areas by listed fire rated door. It was completed on dated 25th May, 2019.	Corrected

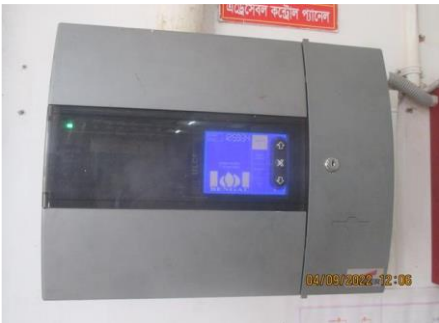
9	Fire detection system installation requires detailed review to confirm compliance with NFPA 72 and ACCORD standards.	Submit as-built drawings, testing records, equipment certification and other relevant documentation to the ACCORD for review and approval. Modification work shall be as per NFPA 72 .	Design within 4 month, installation/ modification within 6 months after drawing review	On 03/10/2018: Extension of timeline is accepted. Extended timeline is valid till 28/06/2019. On 14/05/2019: Installation was going on. On 15/12/2019: Factory requested for timeline extension which is not acceptable. On 19/03/2020: Factory is not ready for Accord T&C according to documents assessment (pre T&C). On 17/11/2020: During T&CVI found that system is not accepted. See T&CVI report for detail. On 31/08/2021 (Special Inspection): Not verified. On 12/12/2021: FVI found that the system is approved. See the detailed FVI Report. On 04/09/2022: Corrected.	28-Jun-2019	We have completed fire detection system installation/modification requirements as per NFPA 72. It has completed on 19th January, 2021. T&C conducted on 17th November, 2020 and all reported issues completed on 12th January, 2021. now we are ready for T & C.	Corrected
